Alliance Elastics

This textile manufacturer installs an insurer approved detection system with Very Early Warning to ensure business continuity.

Customer success story

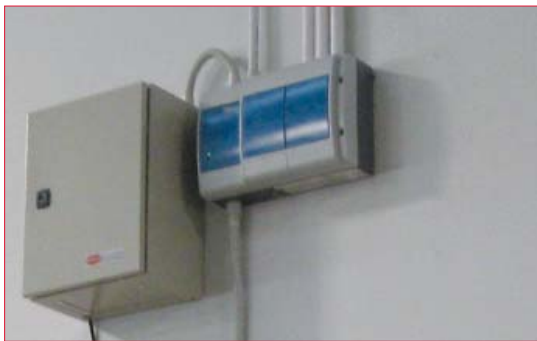
Direct connection from the Xtralis VESDA detector to the existing security panel met the insurer's requirements.

Alliance Elastics requested that Alarmquip undertake the Xtralis VESDA installation. A XtralisVESDA accredited technician and fire system installer completed the final testing and commissioning. The system was connected to the existing security panel to be monitored at a central security station.
